Stories in Stone

National Terrazzo & Mosaic Association

Issue No. 5 Summer 2014

History Lessons: Life Cycle for a lifetime Original Terrazzo 100 years strong in historic courthouses

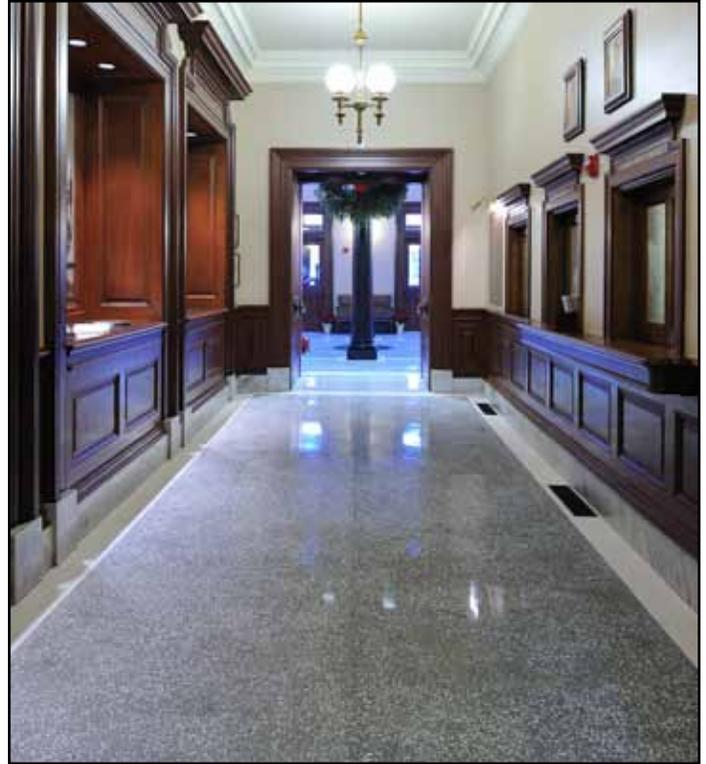
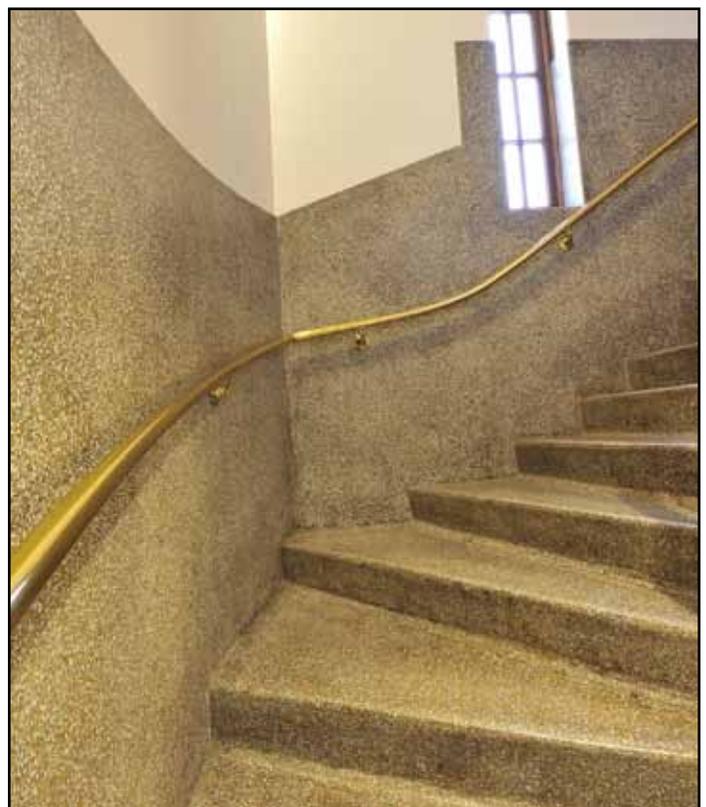
Terrazzo floors were installed in 1905, replacing tiles and wood, along with a major remodel and expansion.

The only signs of age in the Terrazzo today are slightly worn down spots in front of the post office windows where people stood in line for 40 years, and a couple of settlement cracks, Nielsen reported. “Otherwise it doesn’t look worn. You can’t tell it’s 100 years old.”

Widely considered the most historically significant building in the Pacific Northwest, Pioneer Courthouse in Portland, OR, was completed in 1875. Pioneer Courthouse is the oldest federal building in the region and the second oldest courthouse west of the Mississippi. Restorations were done in 1969-73 and again in 2002-05. With a distinguished Italianate design, it was designated a National Historic Landmark in 1977.

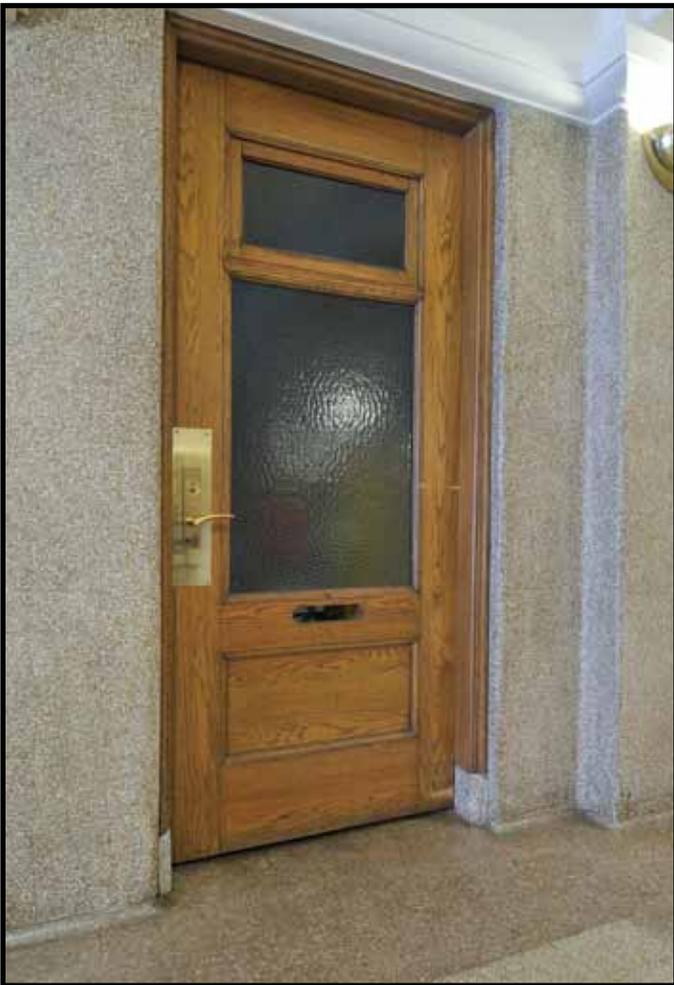
A 2006 survey of conditions found the original geometric-pattern of the historic Terrazzo flooring in the main lobby to be intact and still in generally good condition.

“Wax was obscuring the rich color and depth of the original Terrazzo flooring,” according to an architects’ restoration analysis. The misguided waxing hadn’t damaged the flooring, “except for temporarily clouding its appearance and requiring significant upkeep.”

Years of over-maintenance of Tacoma’s Union Station’s Terrazzo floors had left them looking discolored and deteriorated.

Maintenance costs of the historic floors are now low, Nielsen affirmed. After sealing, only regular sweeping and an occasional damp mopping is needed.

The reflective sheen of the Terrazzo floor now complements the impressive luminosity in the main lobby.
